**DEPARTMENT OF TRANSPORTATION**

Quality Assurance and Source Inspection

Contract #: 04-0120F4Cty: SF/ALA Rte: 80 PM: 13.2/13.9File #: 99.28**WELDING INSPECTION REPORT****Resident Engineer:**Siegenthaler, Peter**Address:** 333 Burma Road**City:** Oakland, CA 94607**Report No:** WIR-017406**Date Inspected:** 05-Oct-2010**Project Name:** SAS Superstructure**OSM Arrival Time:** 700**Prime Contractor:** American Bridge/Fluor Enterprises, a JV**OSM Departure Time:** 1900**Contractor:** Zhenhua Port Machinery Company, Ltd (ZPMC) Chanxing Island**Location:** Shanghai, China**CWI Name:** Mr. Xu Tao**CWI Present:** Yes No**Inspected CWI report:** Yes No N/A**Rod Oven in Use:** Yes No N/A**Electrode to specification:** Yes No N/A**Weld Procedures Followed:** Yes No N/A**Qualified Welders:** Yes No N/A**Verified Joint Fit-up:** Yes No N/A**Approved Drawings:** Yes No N/A**Approved WPS:** Yes No N/A**Delayed / Cancelled:** Yes No N/A**Bridge No:** 34-0006**Component:** OBG Segment & Bike Path**Summary of Items Observed:**

## WELDING INSPECTION REPORT

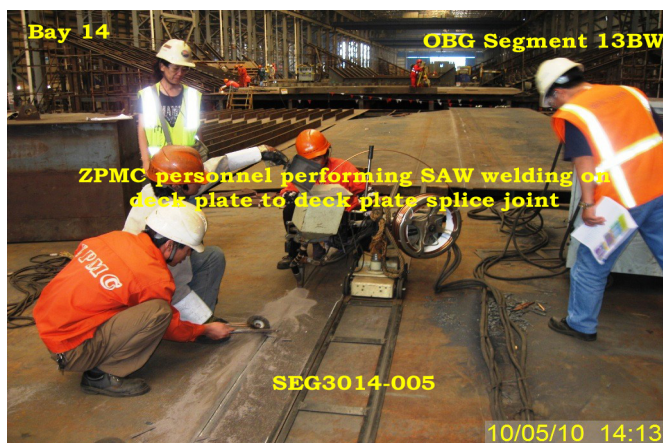
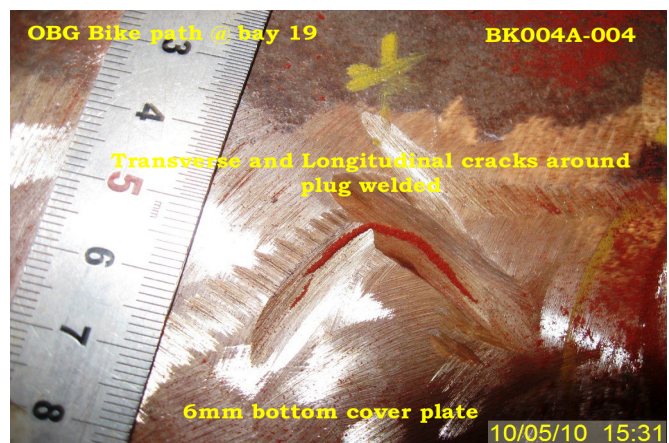
Description of Incident: During random in-process visual inspection of welds located on OBG Bike path at bay 19, this Quality Assurance Inspector (QA) observed that ZPMC personnel performing repair welding on bottom cover plate plug weld repair area with cracks. QA is visually found more than 20 spots transverse and longitudinal cracks around plug welded areas. ZPMC welding personnel performed welding over cracks. The cracks are not removed completely. This QA requested to ZPMC QC, to perform critical welding report as per approved CWR and immediately cross check with MT. The bike path number is identified as BK004A-004. The weld is non Seismic Performance Critical Members (non SPCM). The thickness of the bottom cover plate is 6mm. This bike path is located at bay #19. The indications are clearly marked by QA on/near the weld. See the attached picture.
